Release Note for AlliedWare Plus Software Version 5.5.2-2.x

AlliedWare Plus OPERATING SYSTEM

AMF Cloud
SBx81CFC960
SBx908 GEN2
x950 Series
x930 Series
x550 Series
x530 Series
x530L Series

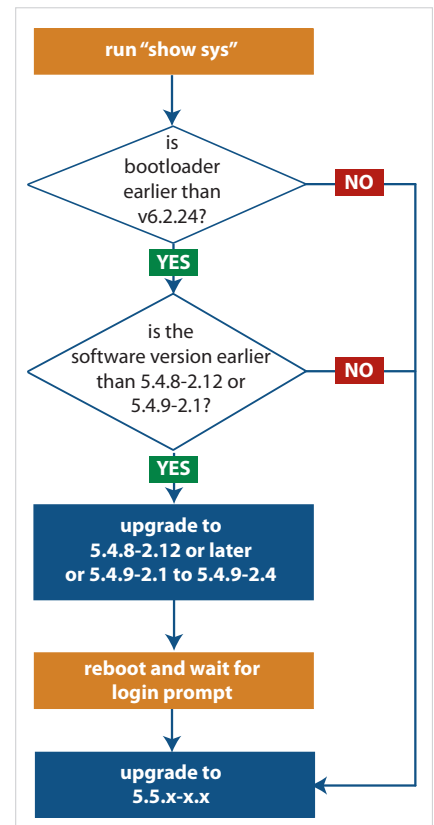
To see your bootloader and current software version, check the "Bootloader version" and "Software version" fields in the command:

```
awplus# show system
```

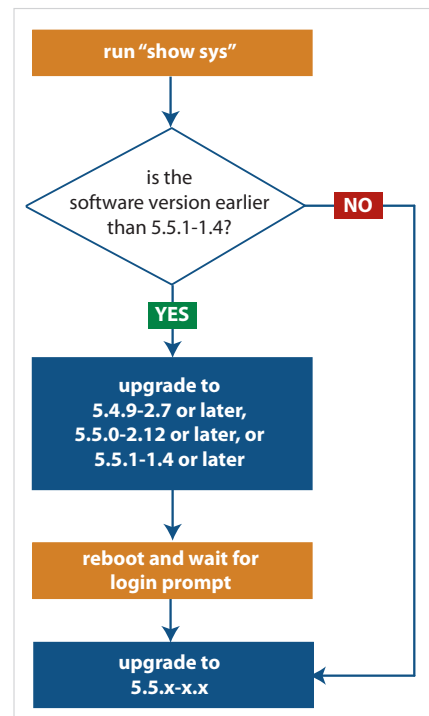
To see your current software version, check the "Software version" field in the command:

```
awplus# show system
```
