AT-S95 Version 2.0.0.26

AT-8000GS Switch

Software Release Notes

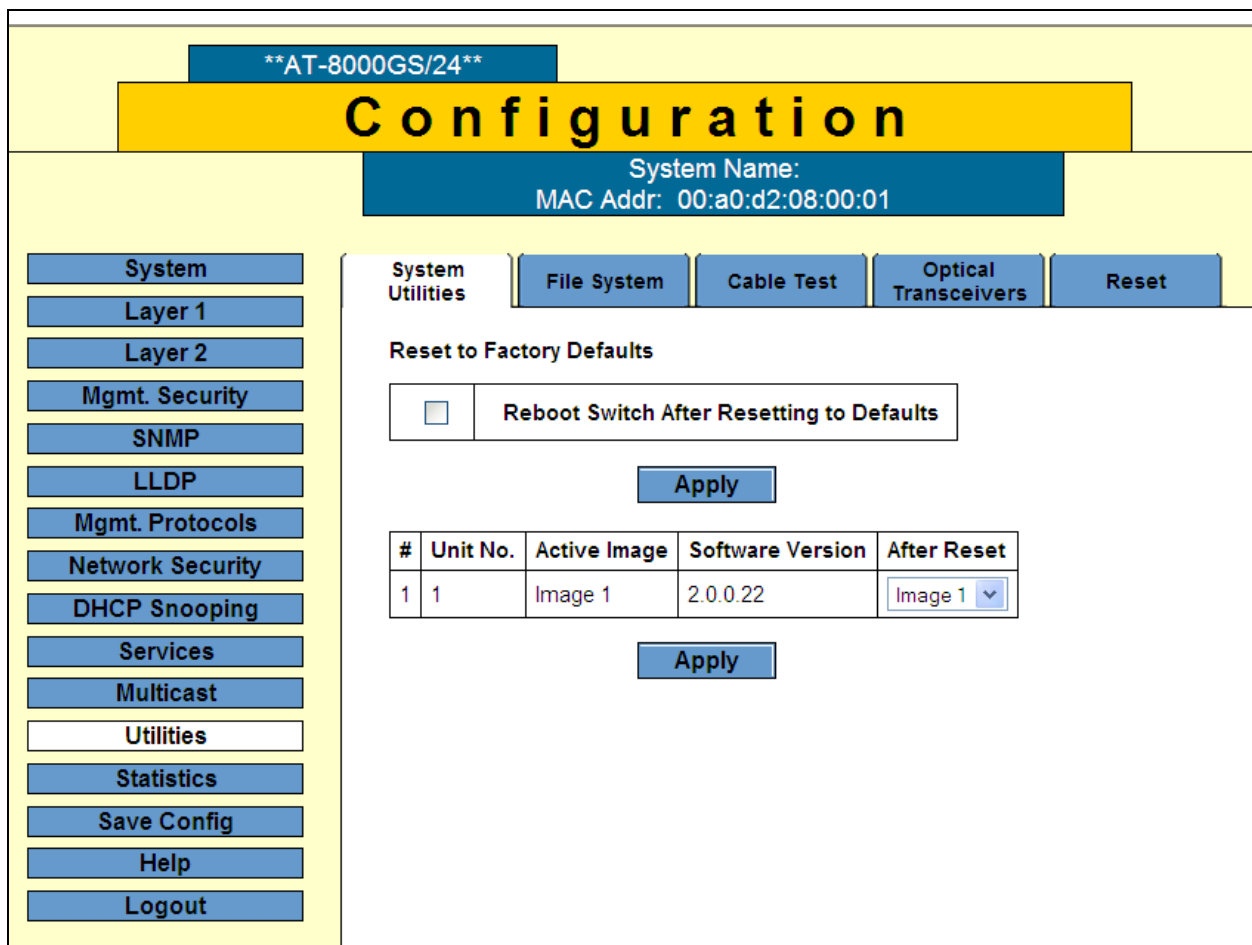
Figure 1. Utilities Tab

1. From the bookmarks on the left side of the page, select the Utilities tab. See Figure 1.

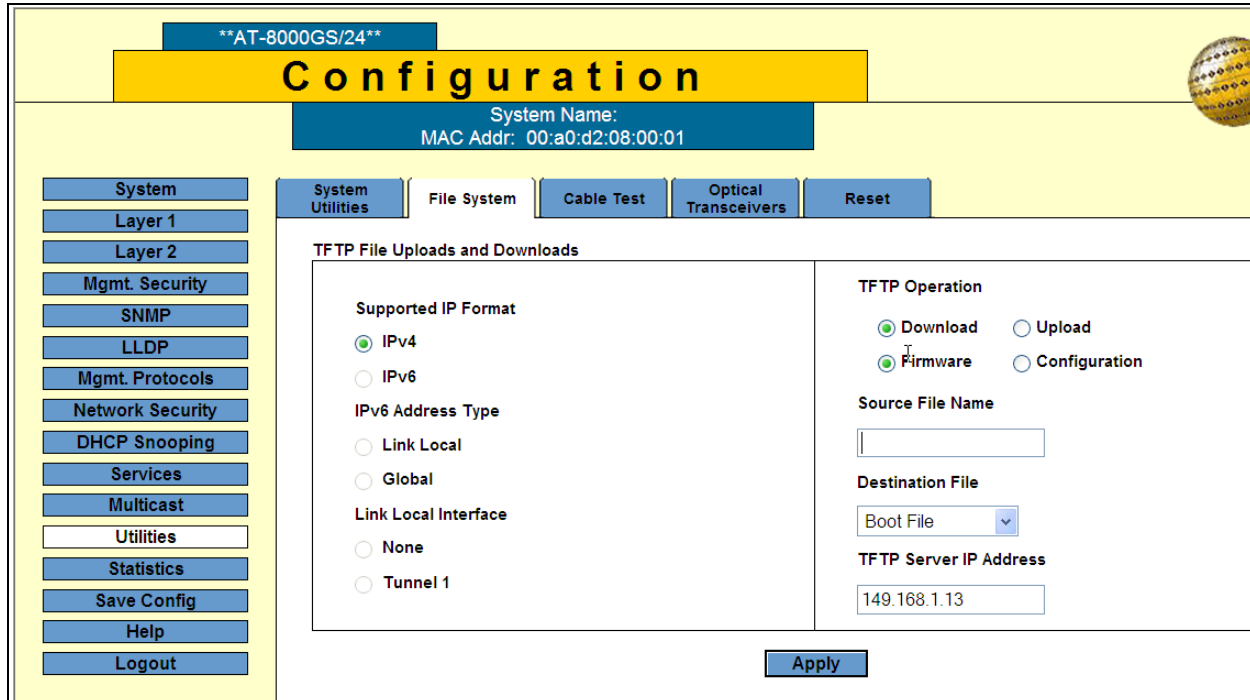
Figure 2. File System Tab

2. Select the File System tab from the top of the page.

The File System tab is displayed. See Figure 2 on page 5.

3. Select the type of TFTP operation to perform. Click both of the following:
 - Download
 - Firmware
4. In the Source File Name field, type the bootloader filename:

ati8000gs_boot-2001.rfb
5. From the pull down menu under the Destination File heading, select **Bootfile**.
6. Enter the IP address of the TFTP server in the TFTP Server IP Address heading.
7. Click **Apply**.
